Ordinary Meeting of Council

Date: Friday 20th November 2020

Late Reports:

- ★ Item CEO5 Application for Freehold Title for Lot 28 on WI51
- ★ Item DWO2 Preliminary Designs – Caretaker’s Cottage
- ★ Item DWO5 Boulia Drinking Water Quality Management Plan

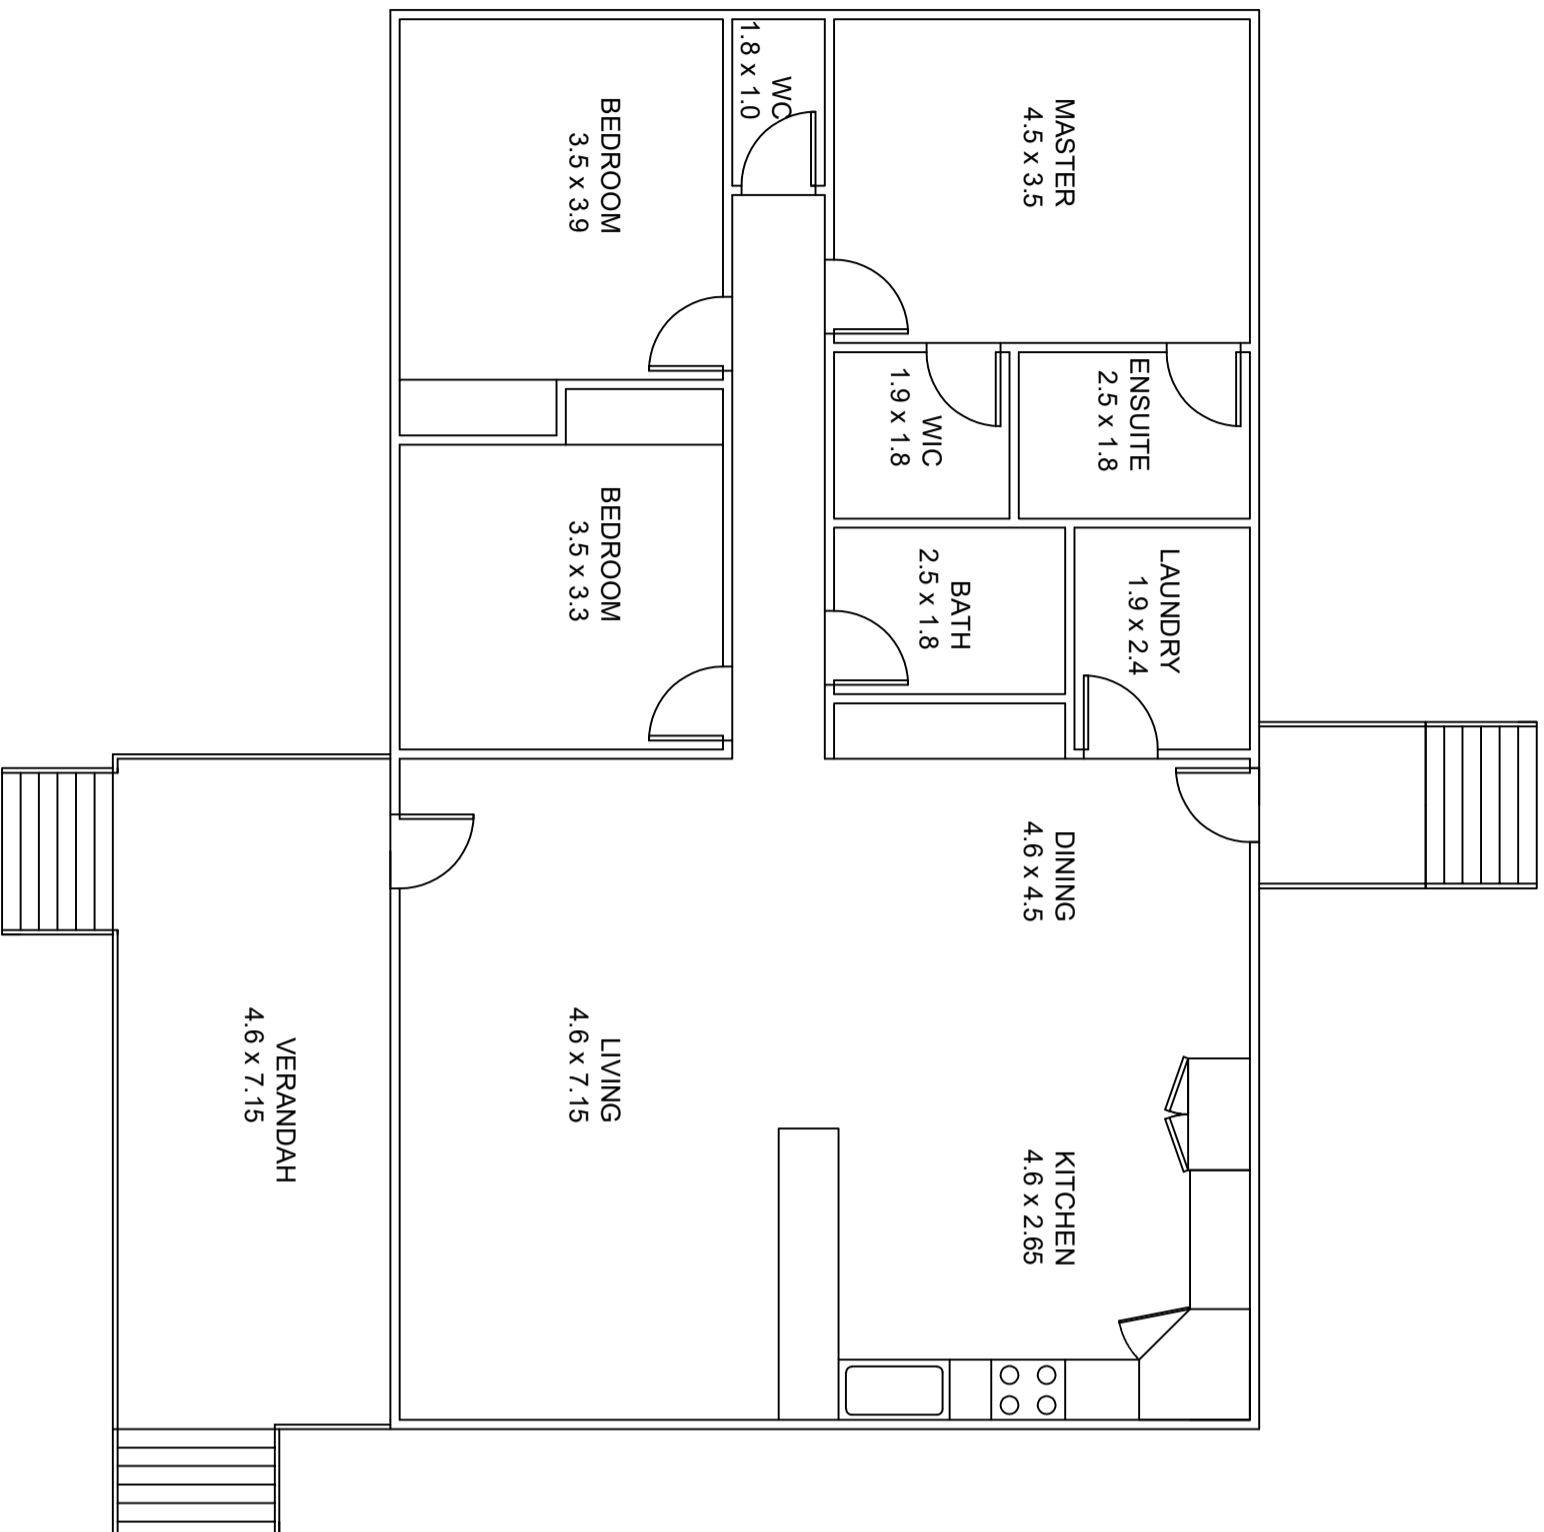
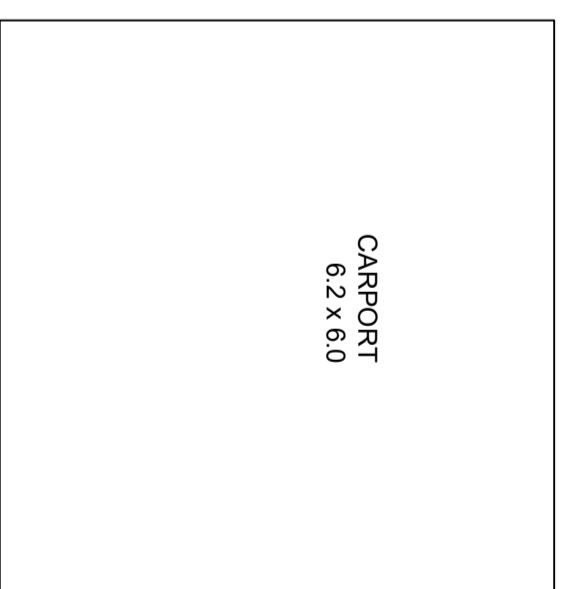
RODEOGROUNDS 3 BEDROOM HOUSE FLOOR PLAN

AREAS
INTERNAL AREA: 139.4m²
DECK AREA: 25m²
CARPORT: 37.2m²

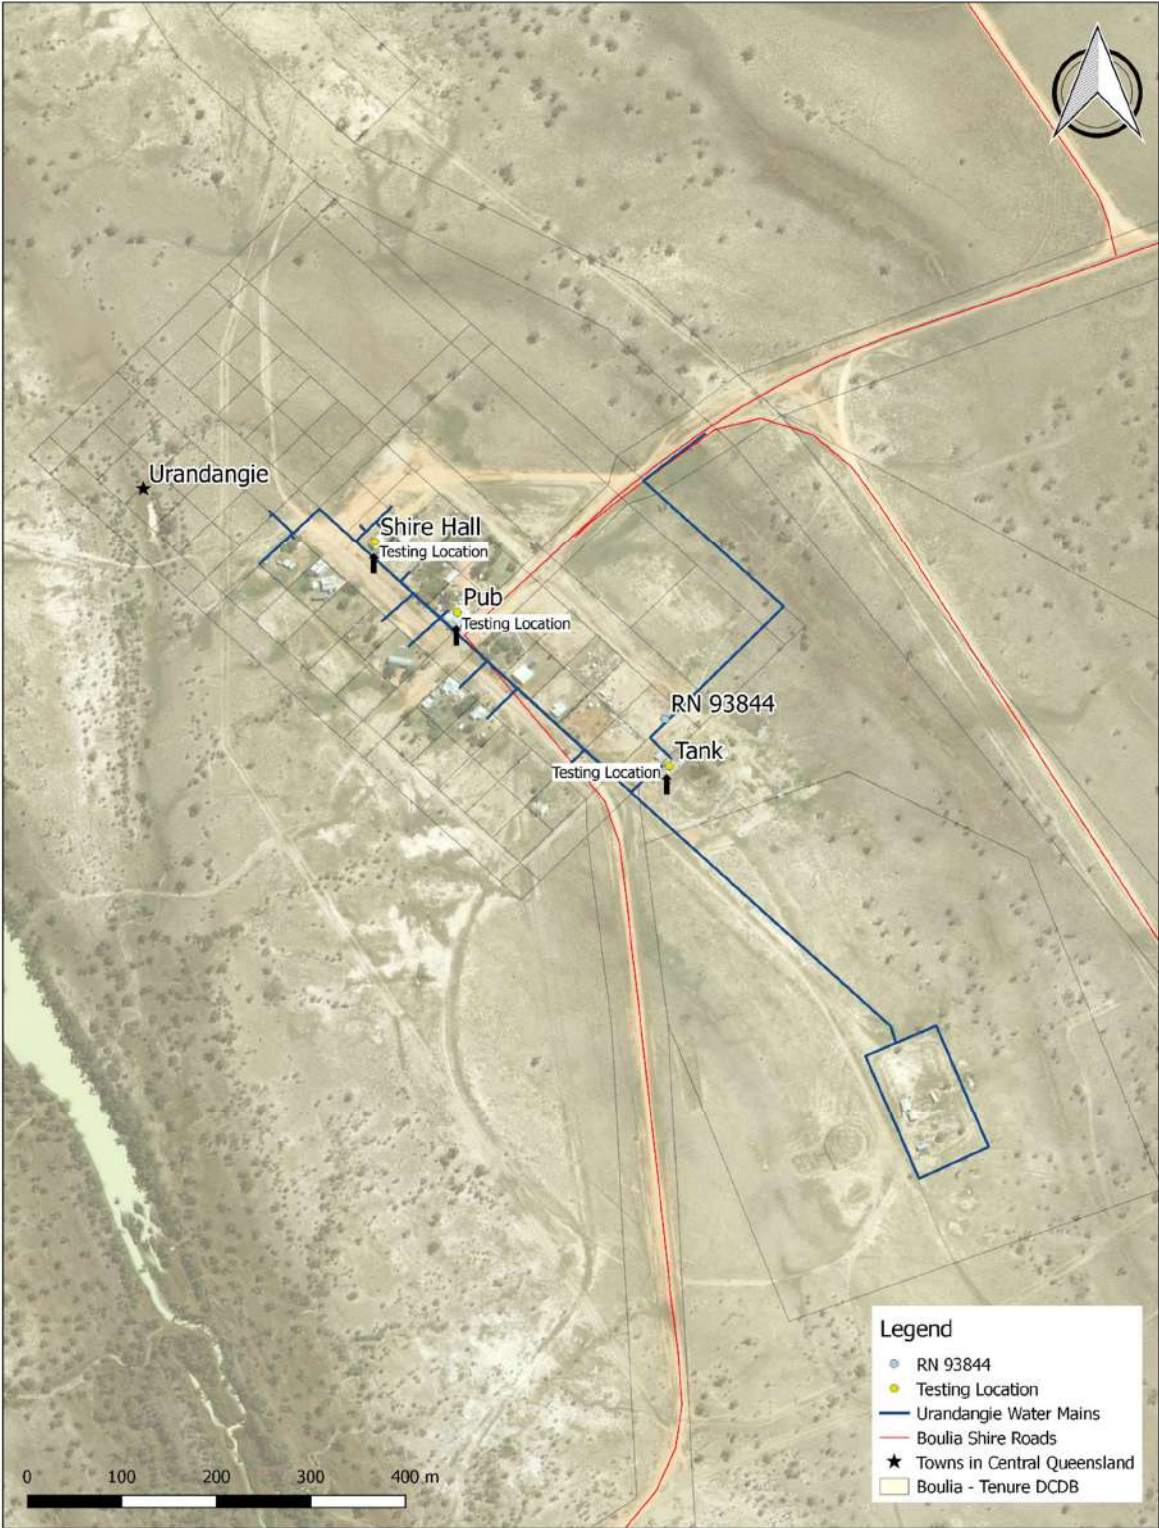
Boulia Shire Council
Urandangie Water Supply

1. Boulia Water Supply Scheme
2. Urandangie Water Supply Scheme
